**Flood Control Project Maintenance
Levee Inspections**
LMA District Cover Sheet
Spring 2011 Levee Inspection Results

Lake County Watershed Protection District

Levee Inspection Report By Mile - Spring 2011

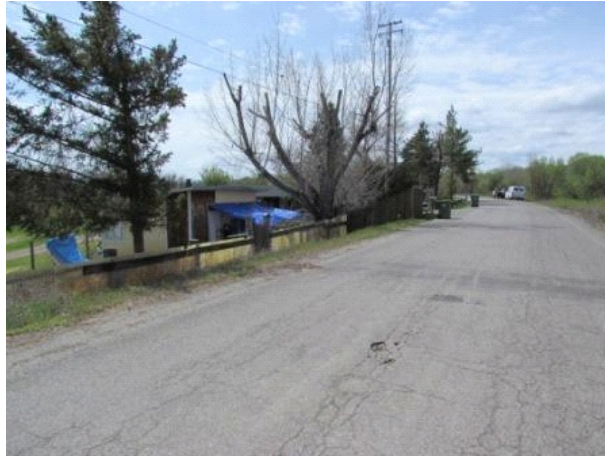
Levee Mile Report Line	3
Start Levee Mile	2.58
End Levee Mile	2.61
Location	Land Side
Category	Earthen Levee
Item	Encroachments

LMR No.	Levee Mile		Category	Item	* Location	** Rating	Action/Comment	GPS Latitude/Longitude		Issue No. Photo
	Start	End						Start	End	
1	2.40	2.40	Earthen Levee	Encroachments	LS	PO	Buildings	39.160217 ° -122.912957 °	39.161692 ° -122.911748 °	7
2	2.48	2.55	Earthen Levee	Vegetation	LS	M	Remove the wild growth other than native grasses from the levee slopes.	39.161615 ° -122.911733 °	39.160795 ° -122.912442 °	3
3	2.58	2.61	Earthen Levee	Encroachments	LS	PO	Fences	39.160398 ° -122.912837 °	39.159952 ° -122.913220 °	4 Y
4	2.62	2.67	Earthen Levee	Encroachments	LS	PO	Landscaping	39.159657 ° -122.913345 °	39.159657 ° -122.913345 °	5
5	2.68	2.73	Earthen Levee	Vegetation	LS	M	Remove the wild growth other than native grasses from the levee slopes.	39.159117 ° -122.913442 °	39.158408 ° -122.913557 °	6

View of the fences at the L/S toe.

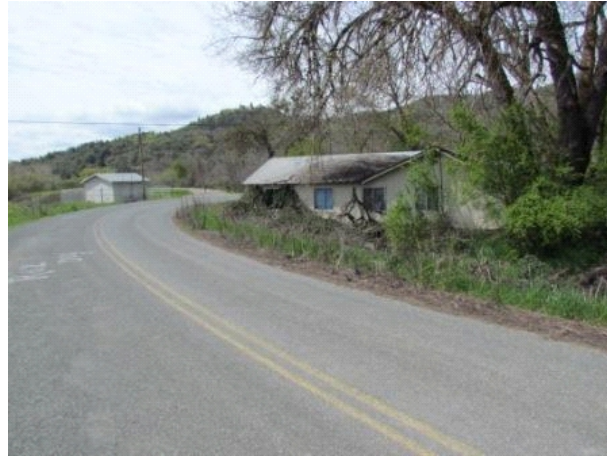
Levee Mile Report Line	1
Start Levee Mile	0.20
End Levee Mile	0.20
Location	Land Side
Category	Earthen Levee
Item	Encroachments

LMR No.	Levee Mile		Category	Item	* Location	** Rating	Action/Comment	GPS Latitude/Longitude		Issue No. Photo
	Start	End						Start	End	
1	0.20	0.20	Earthen Levee	Encroachments	LS	CO	Buildings	39.187039 ° -122.908880 °	39.187039 ° -122.908880 °	1 Y
2	1.03	1.04	Earthen Levee	Vegetation	LS	M	Remove the wild growth other than native grasses from the levee slopes.	39.177218 ° -122.913673 °	39.176992 ° -122.913642 °	7
3	1.05	1.05	Earthen Levee	Encroachments	LS	PO	Buildings	39.176875 ° -122.913685 °	39.176875 ° -122.913685 °	5 Y

View of the vegetation and building next to the landside toe of levee.

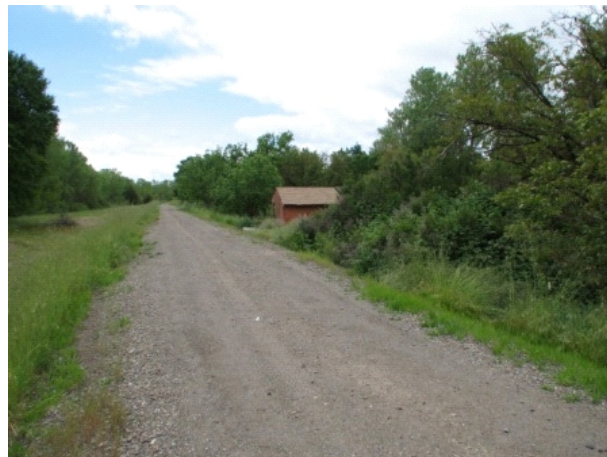
Levee Mile Report Line	3
Start Levee Mile	1.05
End Levee Mile	1.05
Location	Land Side
Category	Earthen Levee
Item	Encroachments

View of building & vegetation along the levee toe.

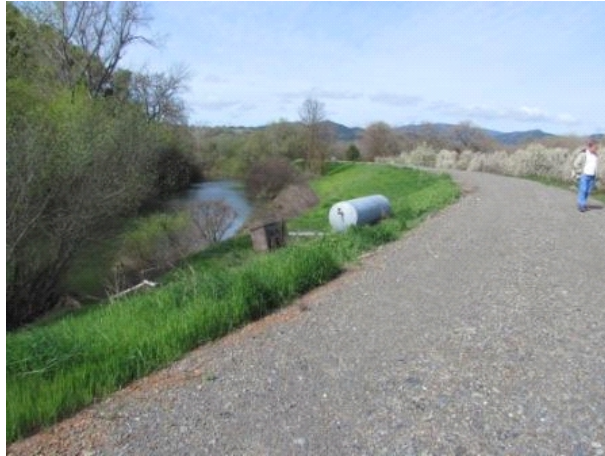
Levee Mile Report Line	1
Start Levee Mile	0.97
End Levee Mile	0.97
Location	Water Side
Category	Earthen Levee
Item	Encroachments

LMR No.	Levee Mile		Category	Item	* Location	** Rating	Action/Comment	GPS Latitude/Longitude		Issue No. Photo
	Start	End						Start	End	
1	0.97	0.97	Earthen Levee	Encroachments	WS PO	Tank		39.160108 ° -122.922110 °	39.160108 ° -122.922110 °	1 Y
2	1.06	1.12	Earthen Levee	Vegetation	LS	M	Remove the wild growth other than native grasses from the levee slopes.	39.159772 ° -122.923540 °	39.159605 ° -122.924610 °	4

View of a tank that needs to be removed from the W/S slope.

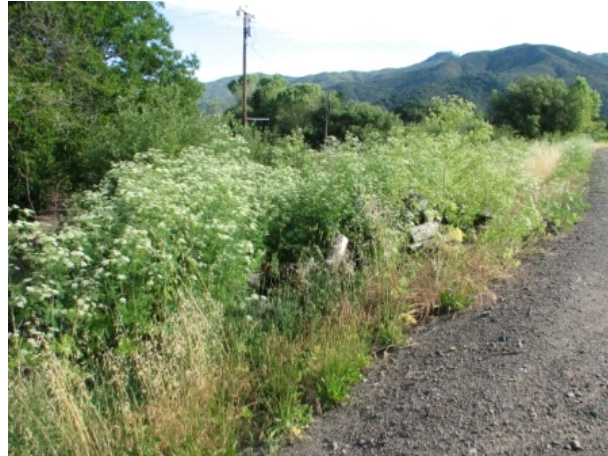
Levee Mile Report Line	2
Start Levee Mile	0.90
End Levee Mile	0.90
Location	Land Side
Category	Earthen Levee
Item	Encroachments

LMIR No.	Levee Mile		Category	Item	* Location	** Rating	Action/Comment	GPS Latitude/Longitude		Issue No.
	Start	End						Start	End	Photo
1	0.82	0.87	Earthen Levee	Encroachments	LS	PO	Fences	°	°	3
								°	°	
2	0.90	0.90	Earthen Levee	Encroachments	LS	M	Garbage	39.178545 °	39.178545 °	1
								-122.896648 °	-122.896648 °	Y
3	1.05	1.18	Earthen Levee	Trim / Thin Trees	LS	M	Trim trees to at least five feet above ground level.	39.180479 °	39.181947 °	2
								-122.896567 °	-122.895112 °	Y

View of the garbage and wood on the landside slope of the levee.

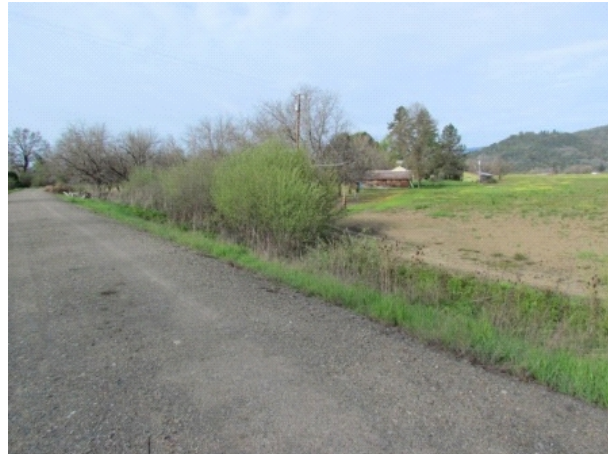
Levee Mile Report Line	3
Start Levee Mile	1.05
End Levee Mile	1.18
Location	Land Side
Category	Earthen Levee
Item	Trim / Thin Trees

View of trees that need to be removed.

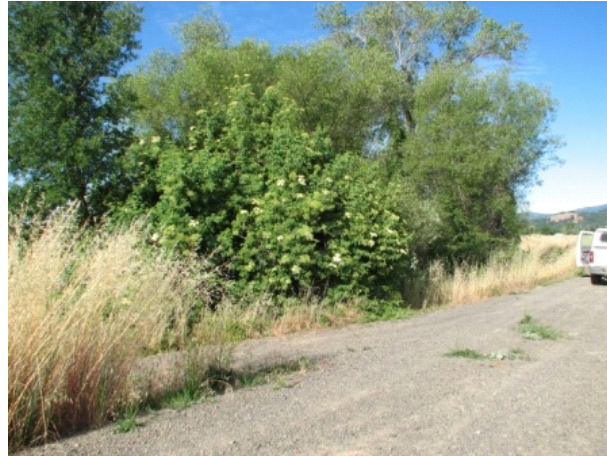
Levee Mile Report Line	1
Start Levee Mile	0.30
End Levee Mile	0.30
Location	Land Side
Category	Earthen Levee
Item	Vegetation

LMR No.	Levee Mile		Category	Item	* Location	** Rating	Action/Comment	GPS Latitude/Longitude		Issue No.
	Start	End						Start	End	Photo
1	0.30	0.30	Earthen Levee	Vegetation	LS	M	Elderberries are blocking visibility and flood fight capability.	39.176957 ° -122.898673 °	39.176957 ° -122.898673 °	3 Y
2	0.55	0.55	Earthen Levee	Vegetation	LS	A	Control annual grass and weeds on the levee slopes and easements.	° °	° °	1 Y

View of the elderberries along the landside toe of the levee.

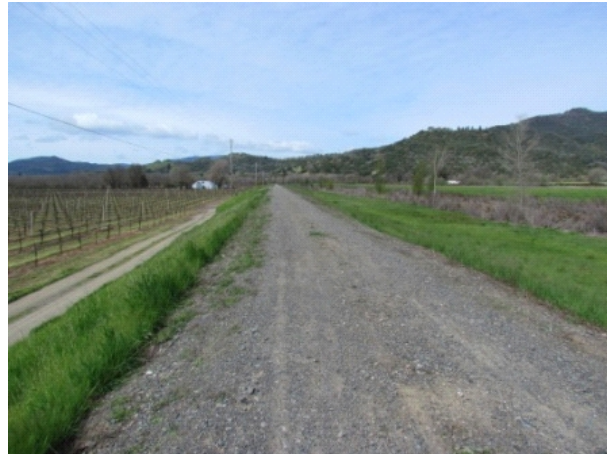
Levee Mile Report Line	2
Start Levee Mile	0.55
End Levee Mile	0.55
Location	Land Side
Category	Earthen Levee
Item	Vegetation

View of the clean levee.
